DEC-11-HMSTS-A-D

**PDP-11/45, 11/50 MOS MEMORY
TROUBLESHOOTING GUIDE**

INTEROFFICE MEMORANDUM

SUBJ:

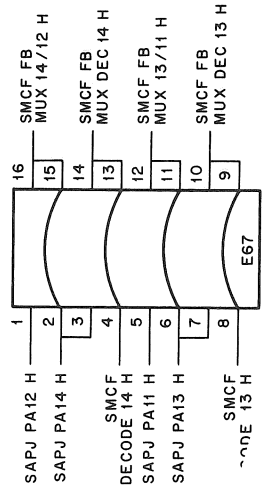
11-1327

Fastbus Interface — The figure below shows the jumper connections at E67 that interface the Fastbus to the controller for MOS memory. Note that bits 13 and 14 are designated for MOS and bits 11 and 12 for bipolar. Note also that SMCF DECODE 14 and SMCF DECODE 13 are connected for MOS memory.

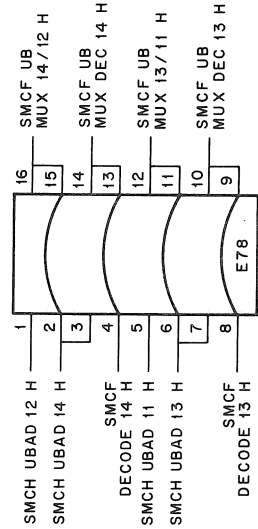
11-1329

Unibus Interface — The figure below shows the jumper connections at E78 that interface the Unibus to the controller for MOS memory. Note that bits 13 and 14 are associated with MOS and bits 11 and 12 are associated with bipolar. Also note that SMCF DECODE 14 and SMCF DECODE 13 are connected for MC

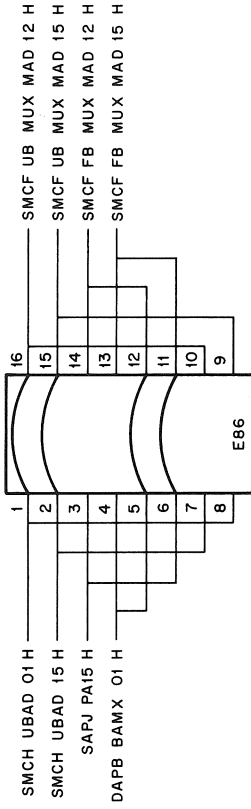
11-1328

E86 Jumpers – E86 jumpers, which are used for interleaving, exist on the B etch only. The SMCF FB MUX MAD 15 H input to NOR gate E89 of the Fastbus address decoder is from another jumper-wired multiplexer, E86, on the M8110 module. The figure below shows the jumper configuration required to route Fastbus/Unibus address bit 15 to the address decoder.

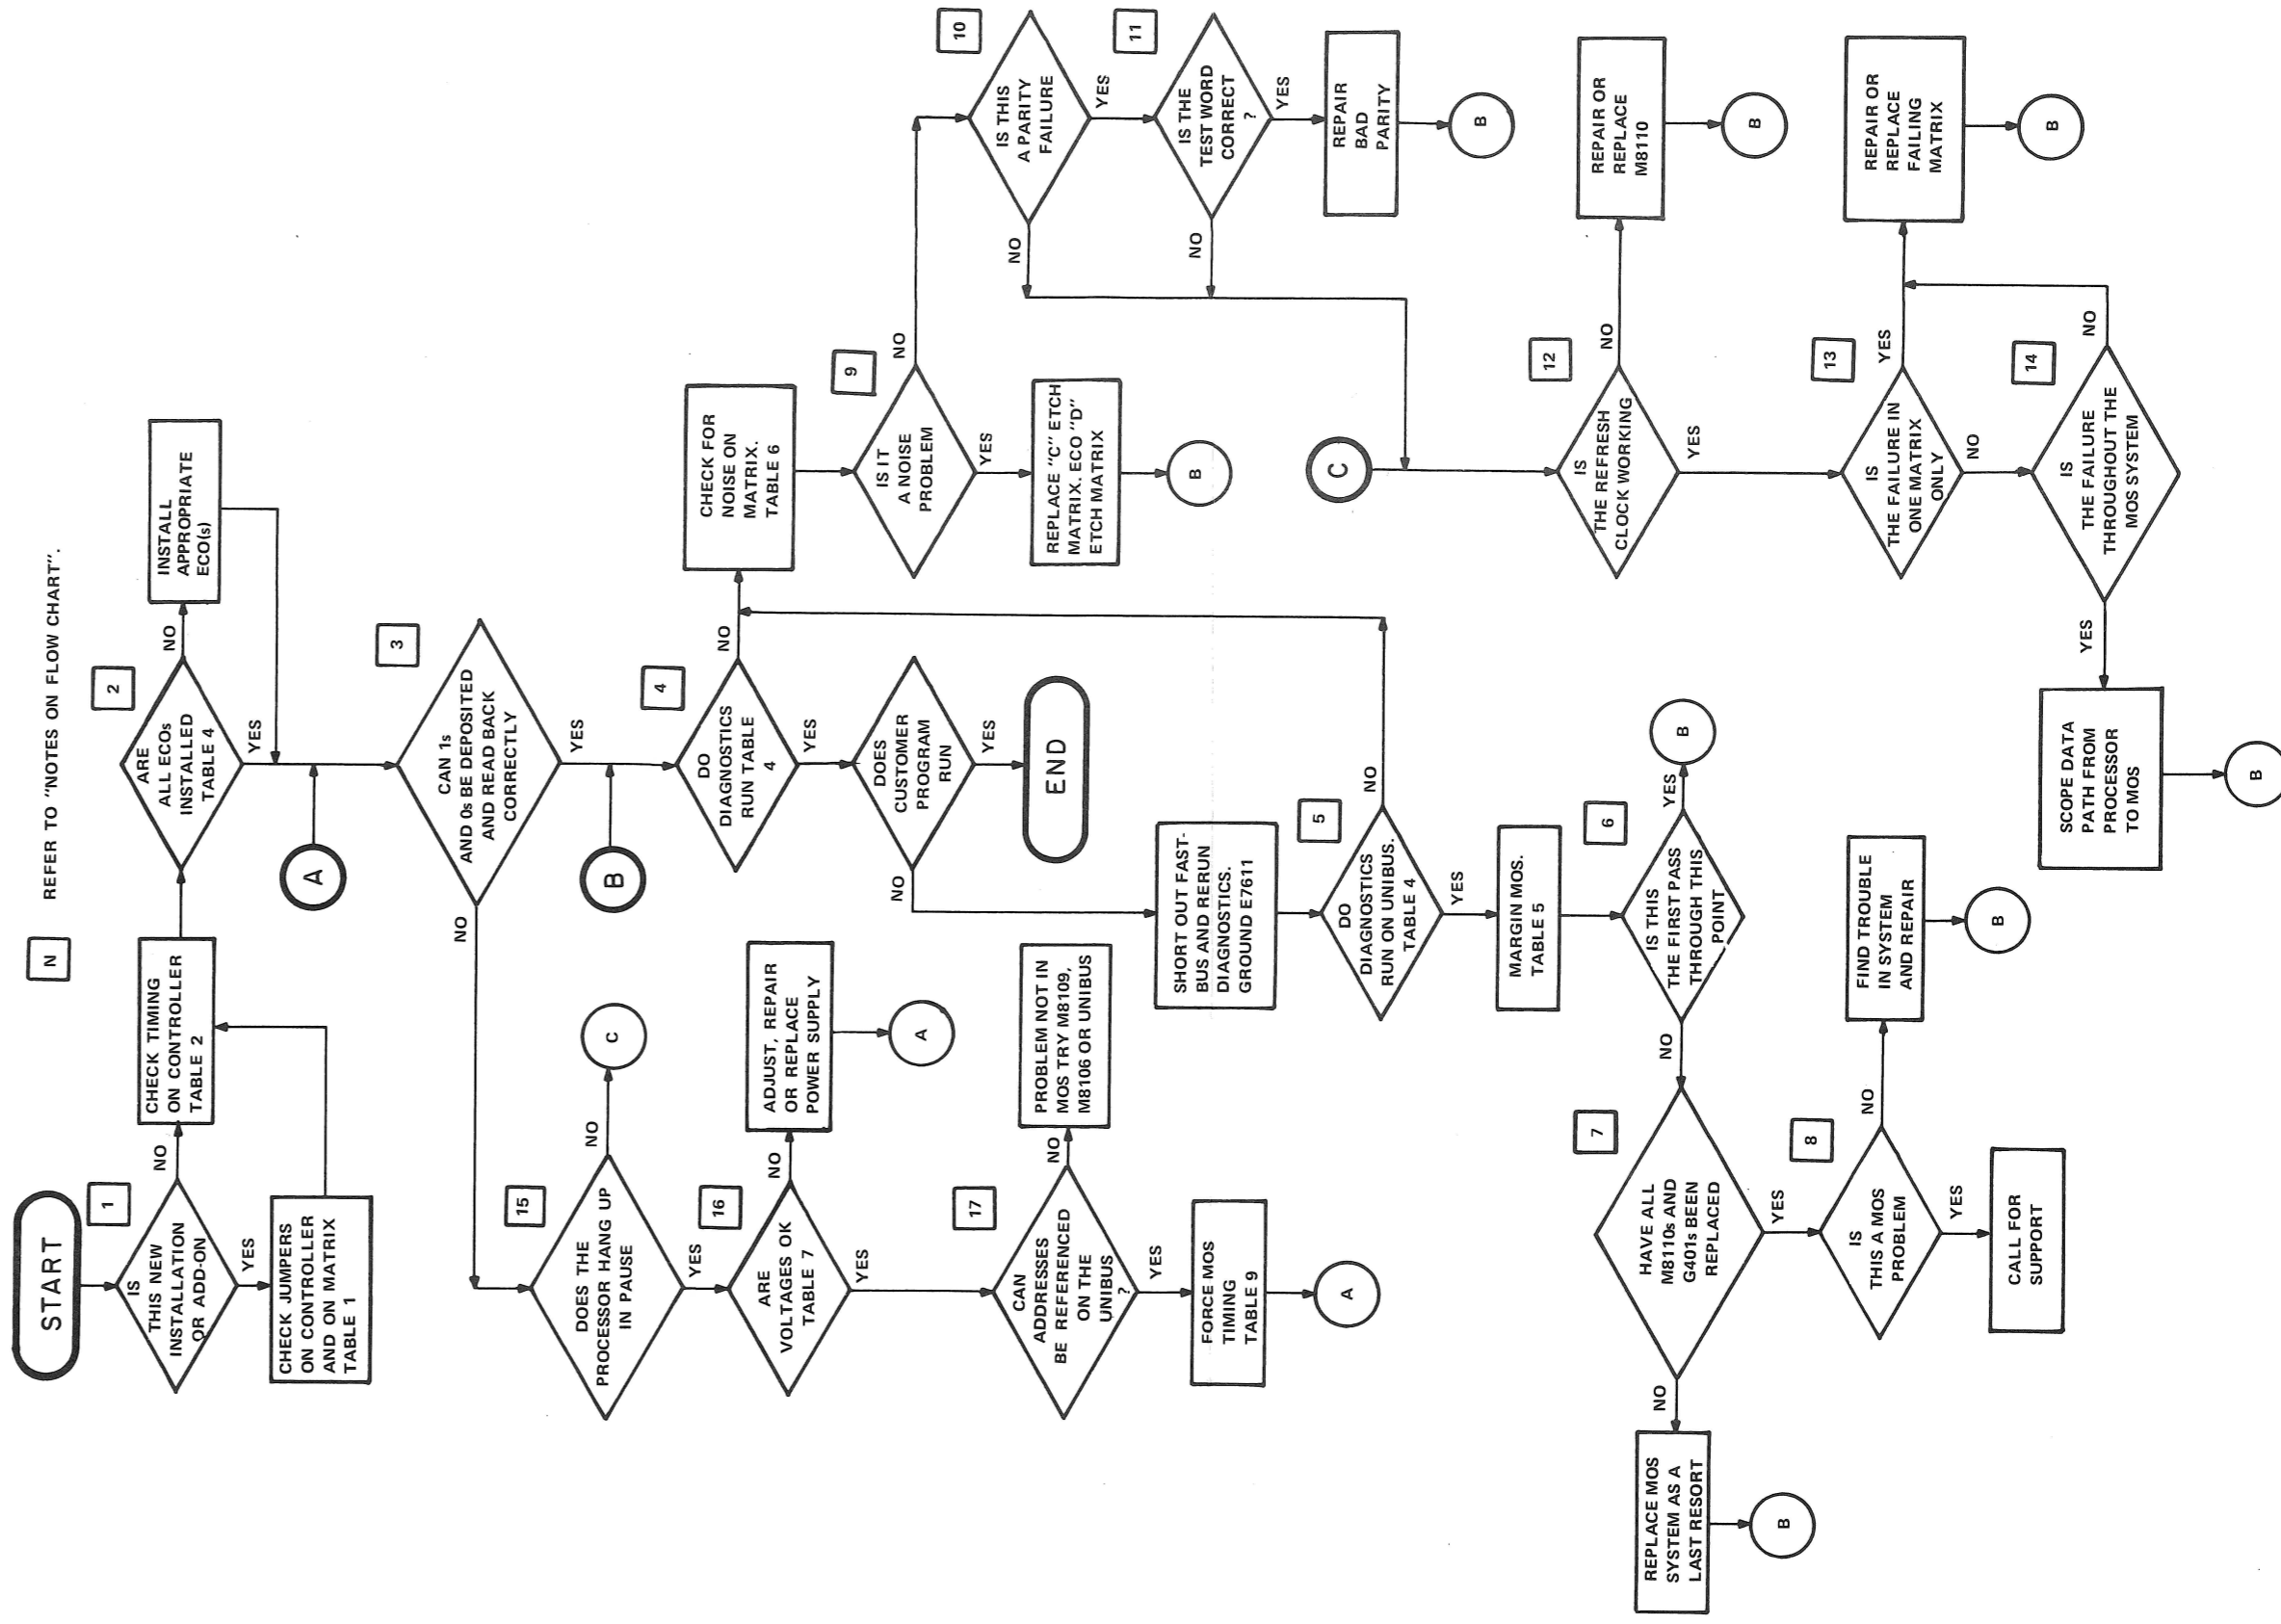
- 4 If software like RSTS-E or some customer software fails, it might take a long time for diagnostics to fail or they might not fail at all. RUN is defined as a minimum of 15 minutes per matrix.

- 5 To test Unibus side of controller.
- 6 If no failure occurs at nominal voltages, margins might help locate the problem.
- 7 If no problem can be found, this is the only thing left to try. Jumpers and timing must be checked after installing new modules.

- 8 If the system has been replaced and the software still will not run, and if the problem is definitely an MOS problem, support is needed.
- 9 A C etch G401 cannot be ECOed to fix noise problems. A D etch G401 can be ECOed to fix noise problems. A C etch G401 should not cause noise problems if less than half of the 37 level shifters are 3207A-1s.

- 10 To check if a parity failure is caused by a parity IC or a data IC.
- 11
- 12 Data storage problems in a matrix are generally caused either by a missing voltage or by an inoperative refresh clock.

- 13 To determine if the failure is in the matrix or elsewhere in the system.
- 14
- 15 To find out why the processor is hanging up in PAUSE.
- 16
- 17
